April 20, 1994

RE: Albion-Sheridan Township Landfill, Septic Tank Inspection

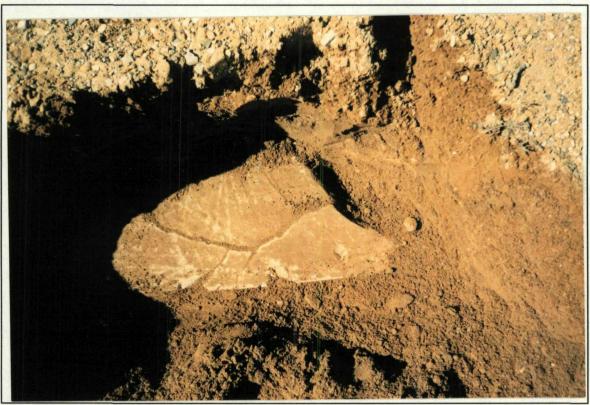
The current condition of the septic tank is unusable, and it appears that the tank could have been damaged during site preparation. At the time of site preparation, WWES was not aware of the existence of the tank.

Comments: This photo shows cracks in the top of the septic tank.

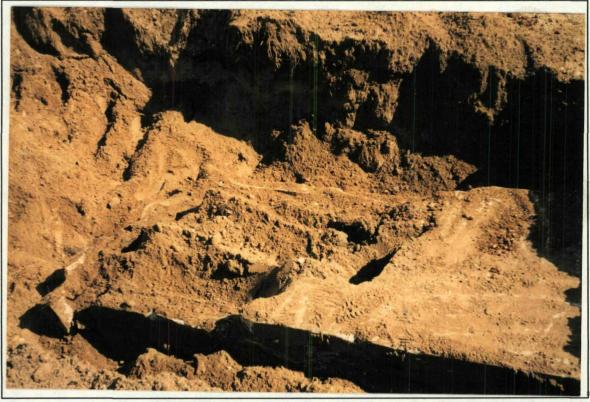
Comments: The cracked pieces of the septic tank top were removed to find that the tank was full of sand and gravel.

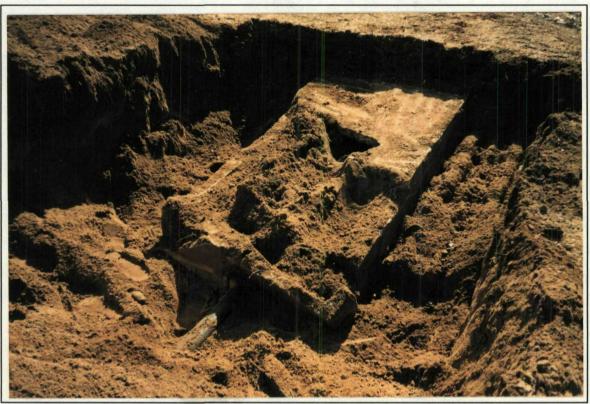
Comments: This photo shows the septic tank is full of sand and gravel, and that the top and sides have been broken. Close examination indicates that the plastic pipe exiting to the northeast is also damaged.

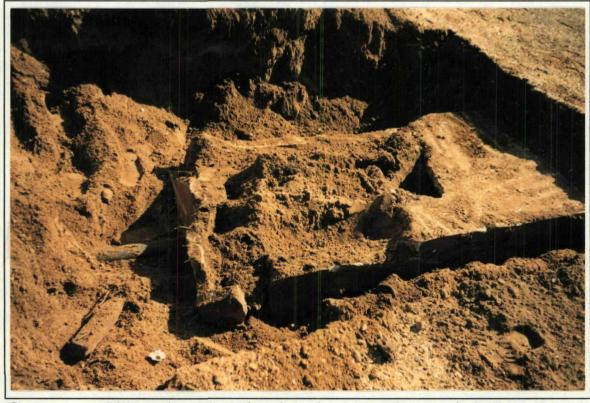
Comments: Different view of the septic tank showing the same damage as in the above photo.

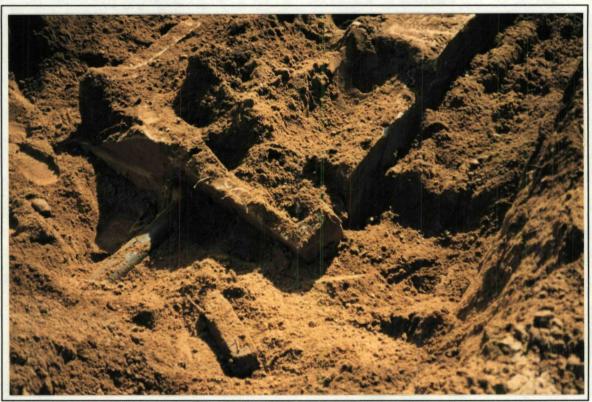
Comments: This photo is a close-up view of the broken sides and pipe.

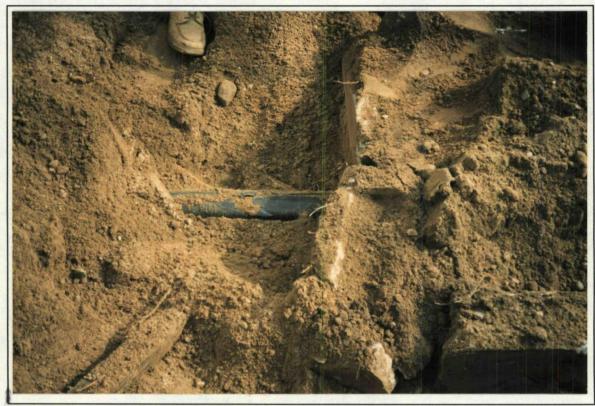
Comments: This close-up photo shows the broken sides and pipe.

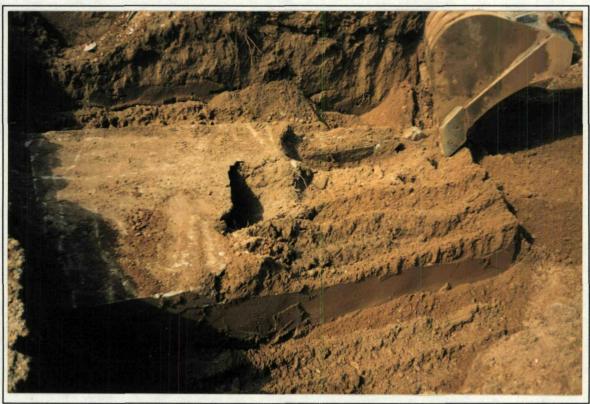
Comments: This photo show the septic tank filled with sand and gravel.

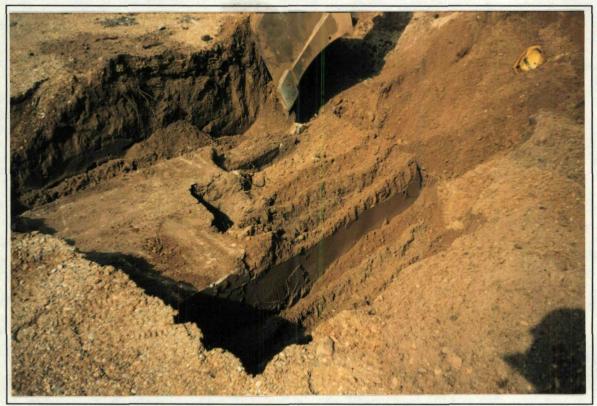
Comments: This photo show the septic tank filled with sand and gravel.

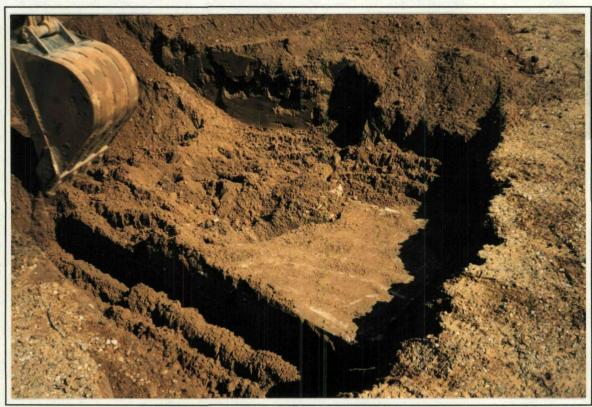
Comments: This photo show the septic tank filled with sand and gravel.
